# Luminaire Dirt Depreciation

*This summary paper reviews various sources of information concerning the issue of luminaire dirt depreciation as it relates to luminaire design and construction. These data compare the dirt depreciation performance of enclosed and gasketed fixtures to open-ventilated, borosilicate glass with hermetically sealed cover reflector systems.*

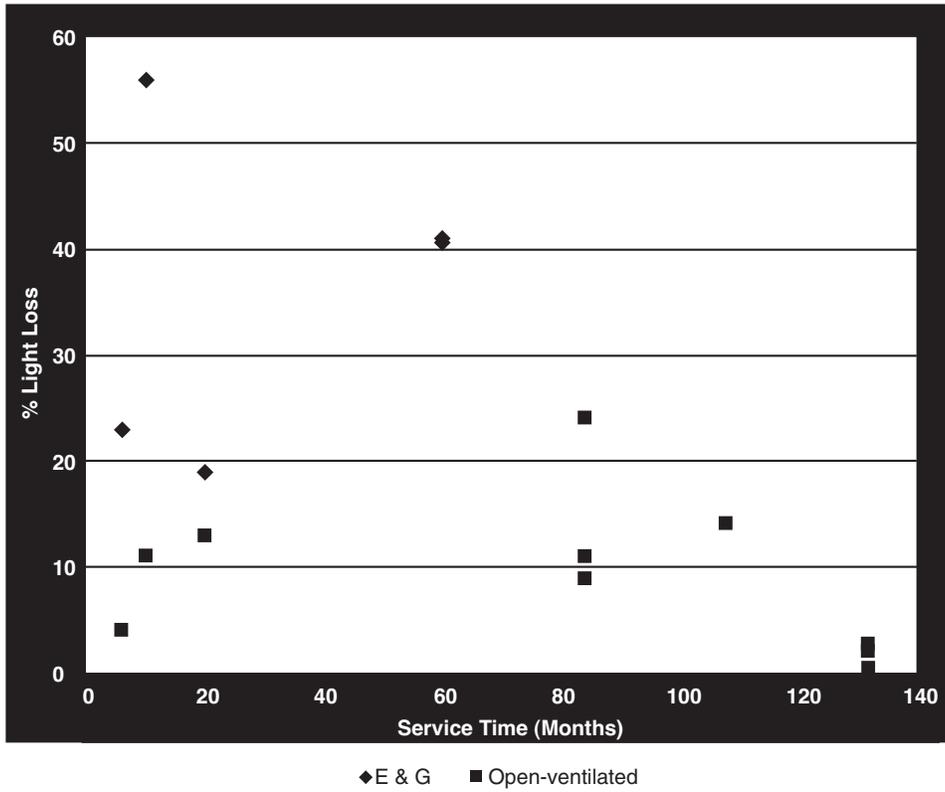
### Luminaire Dirt Depreciation

The data is conclusive! Open-ventilated, borosilicate glass reflectors with a sealed outer cover keep a higher lumen efficiency throughout their life than fixtures of an enclosed and gasketed design. A visual summary is shown on the attached graphs.

of the six (6) month period, photometric tests were conducted to determine the lumen output compared to the lumen output of the fixtures when initially installed. The results indicate that the enclosed and gasketed fixtures experienced depreciation due to dirt of 23% (LDD = 0.77). The open units with aluminum reflector had a luminaire dirt depreciation (LDD) of 0.88 (Light Loss =12%) and the open-ventilated glass reflector unit had a LDD of 0.96 (4% light loss).

sealed outer cover reflector units to enclosed and gasketed units (7). The results reported by EC&M indicated a total LDD for the open-ventilated glass units was 0.86 (14% loss) after nine years in an automobile stamping shop. The LDD for the enclosed and gasketed unit was 0.594 (40.6% loss) after five years in a foundry. They report LDD of just 0.96 (4% loss) for the open-ventilated units compared to 0.77 (23% loss) for the enclosed and gasketed units after six months in a "strongly polluted environment".
